Patriot Harris – System Photos

October 2, 2011

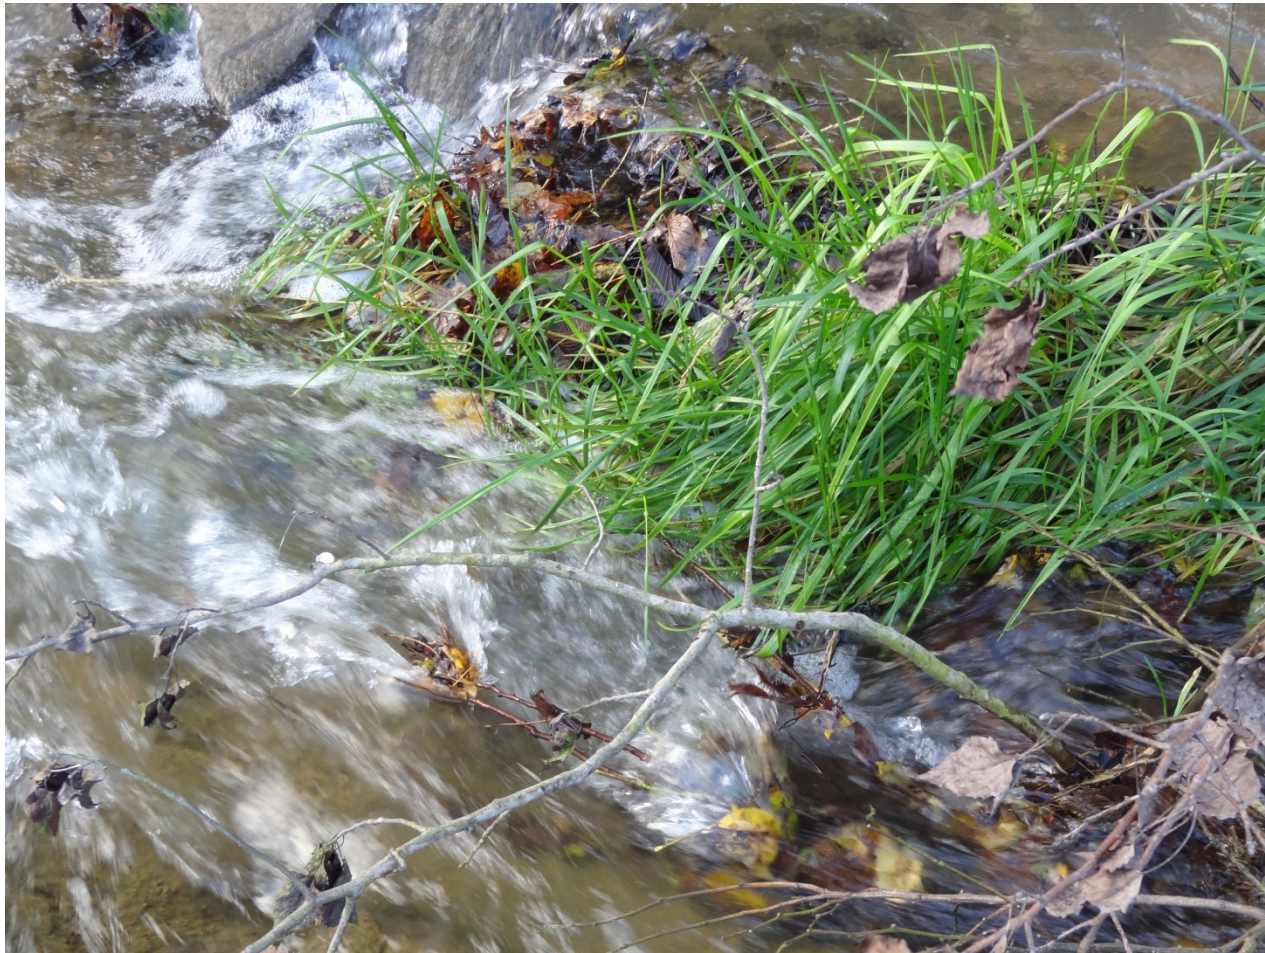
Refuse Outlet Spillway – Post KR-DP0168 Feed

No Staining on Tall Grasses

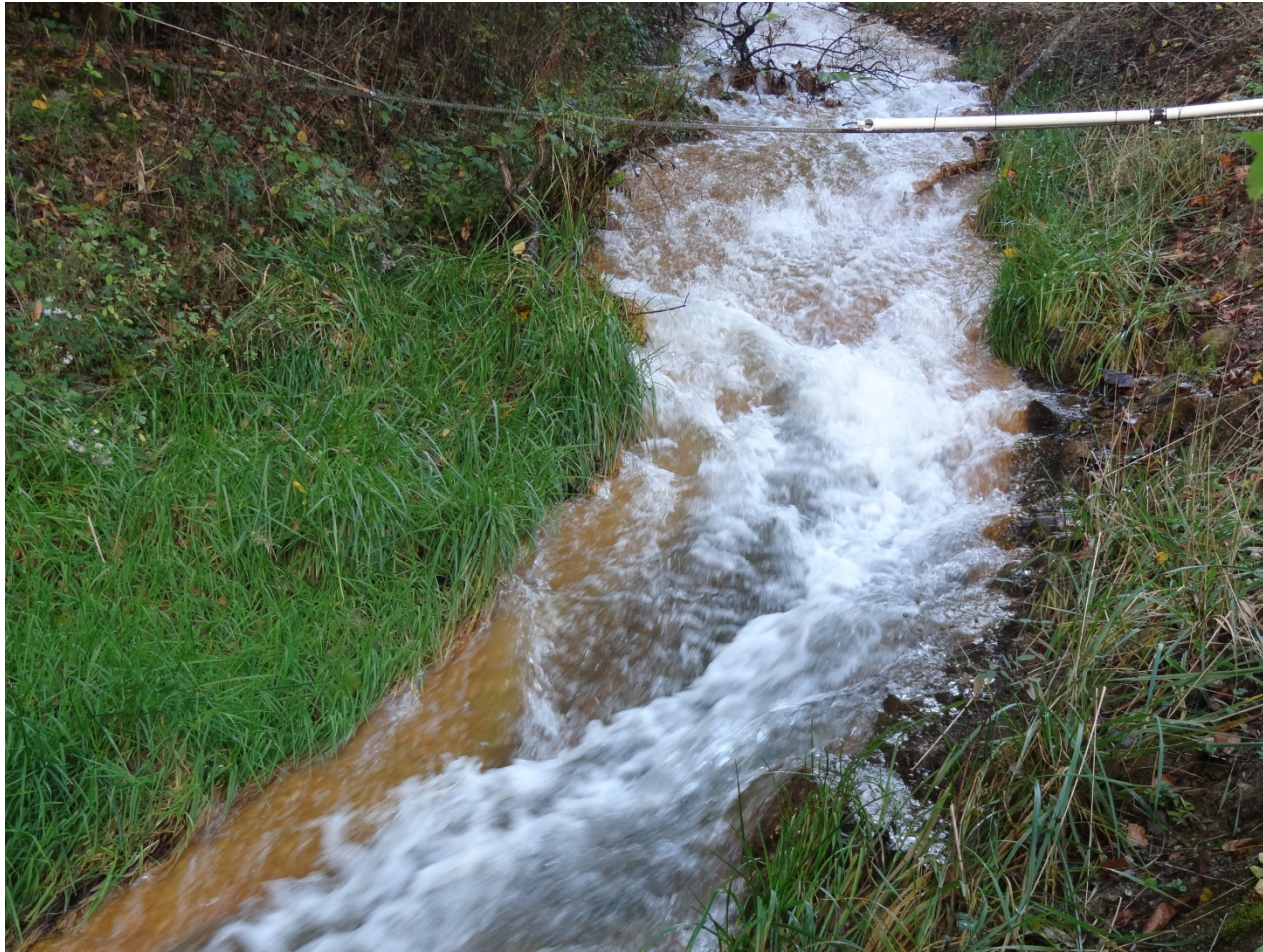
Refuse Outlet Spillway – Post KR-DP0168 Feed

KR-DP0168 Mixing Zone

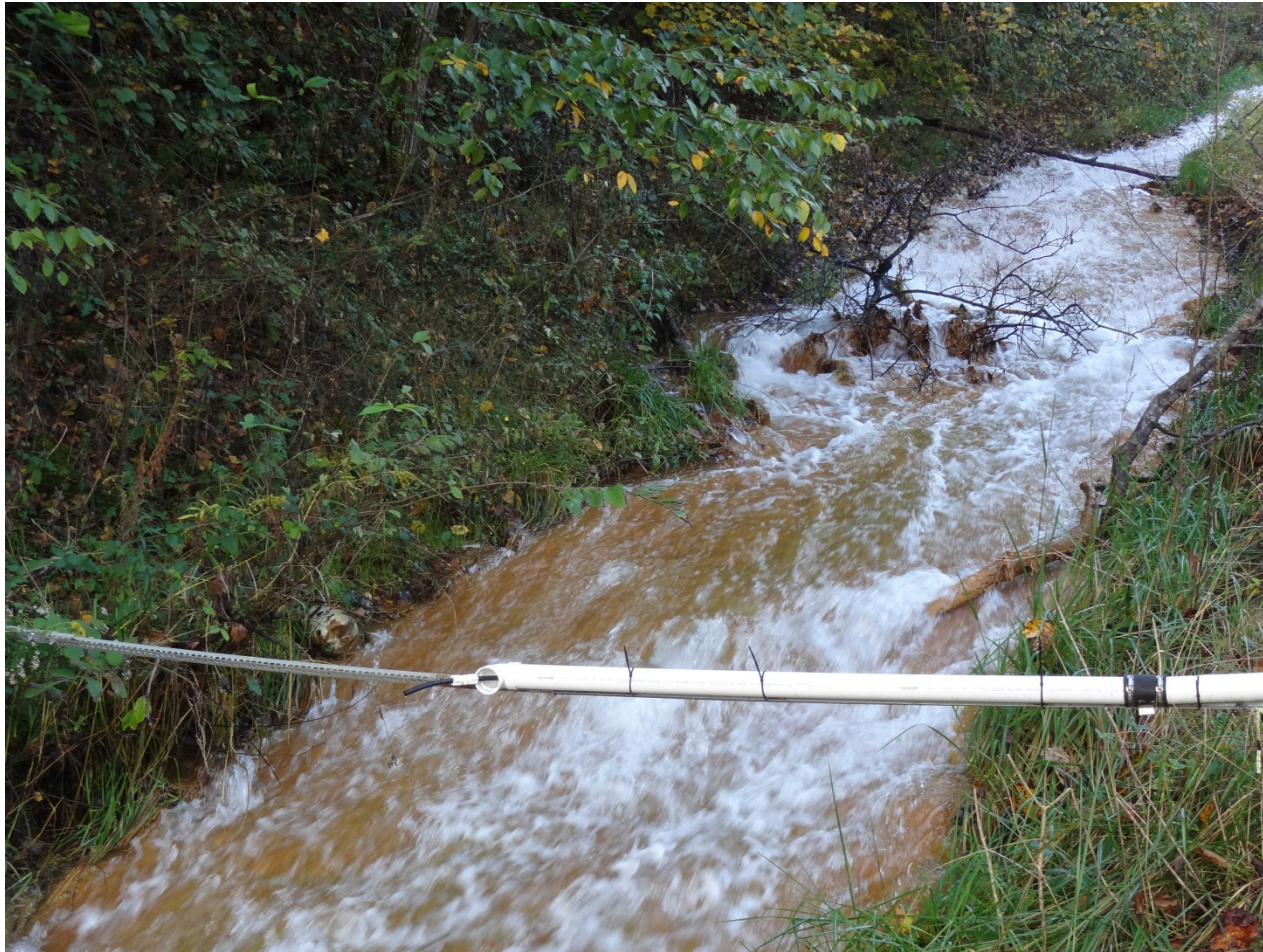
Refuse Outlet Spillway – Pre KR-DP0168 Feed

Staining Evident in Creekbed

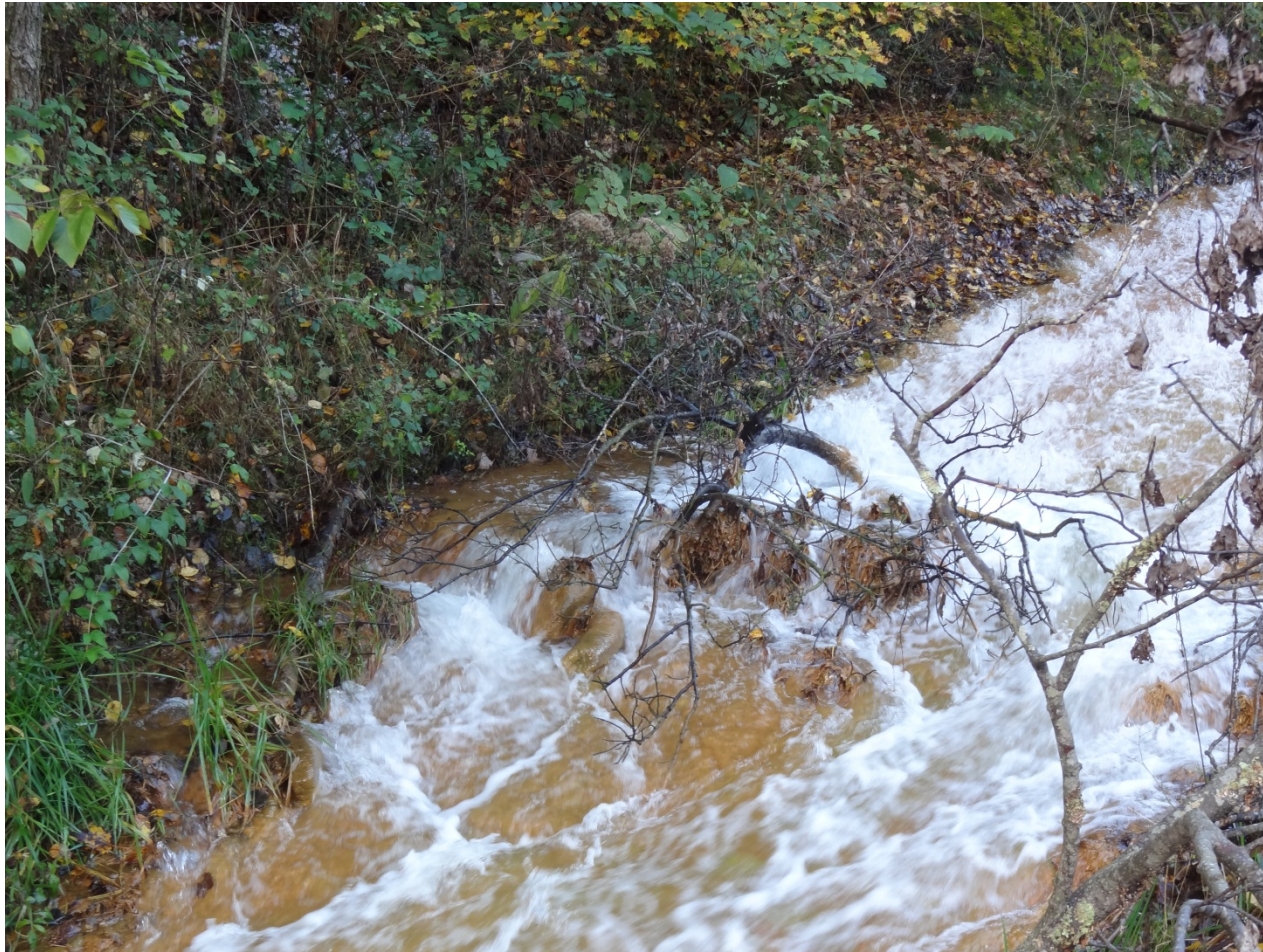
Refuse Outlet Spillway – Pre KR-DP0168 Feed

Staining Evident in Creekbed

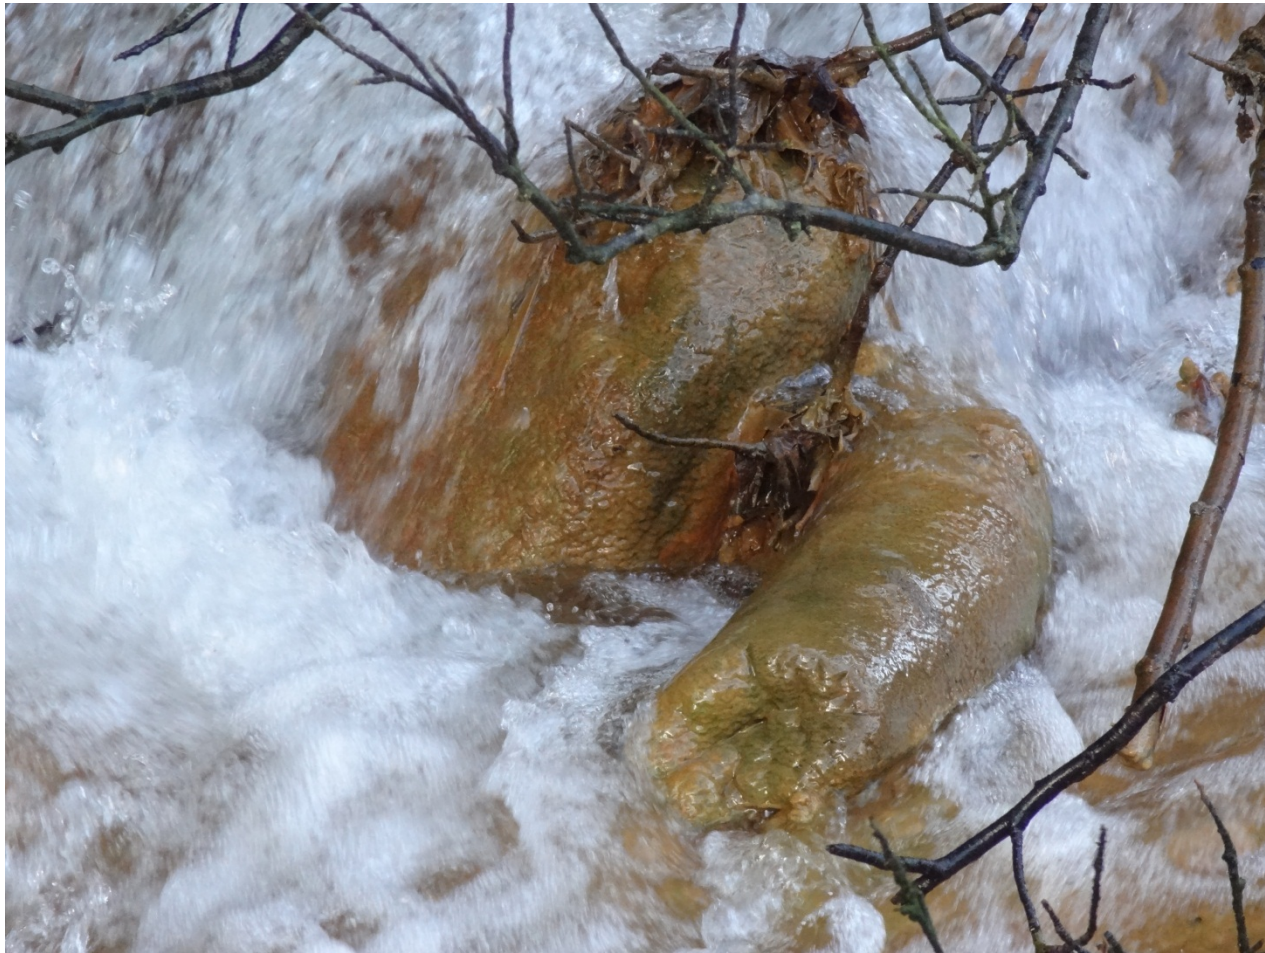
Refuse Outlet Spillway – Pre KR-DP0168 Feed

Close-up of Stained Logs in Creekbed

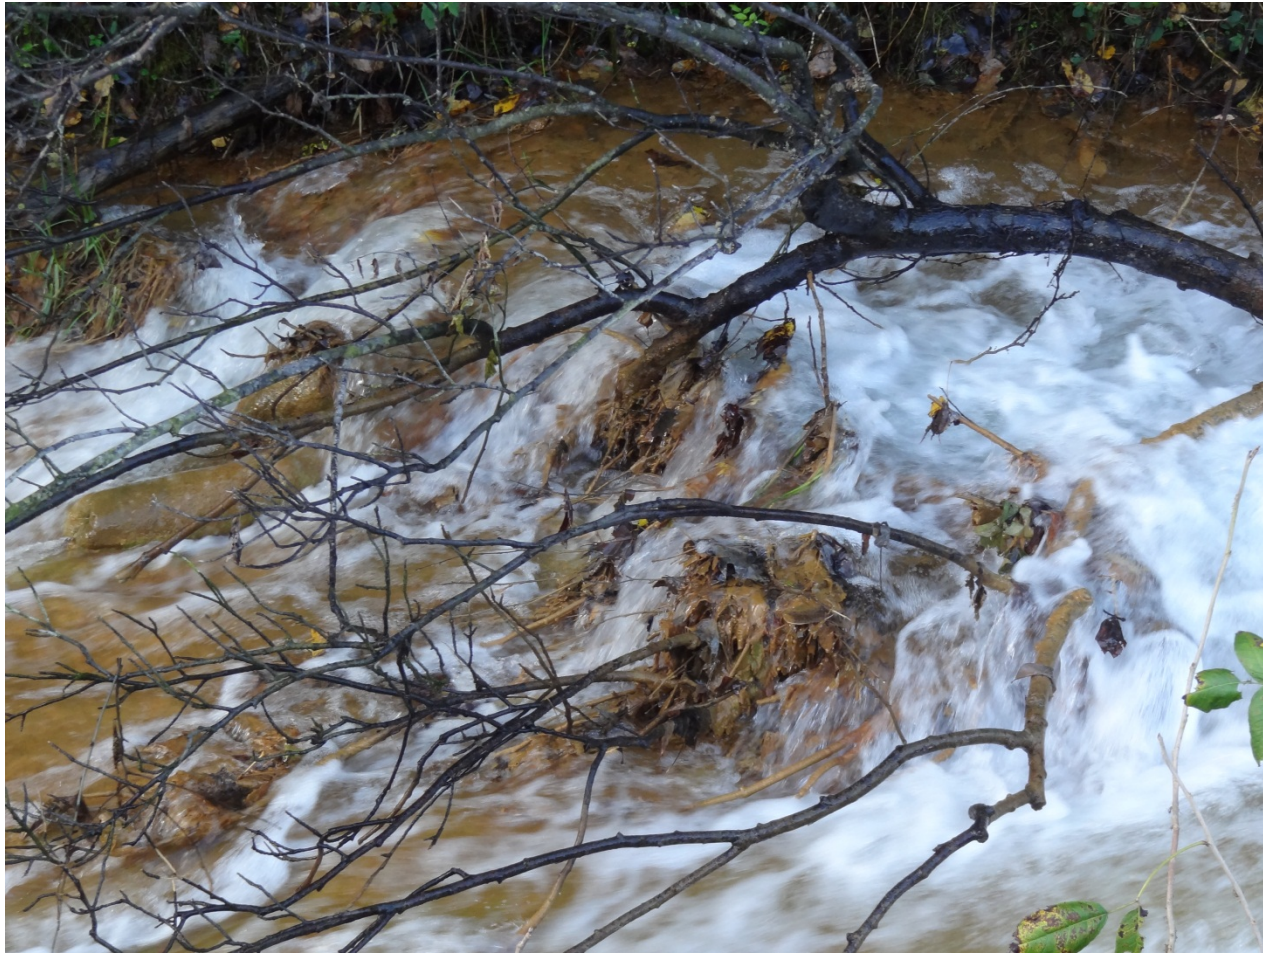
Refuse Outlet Spillway – Pre KR-DP0168 Feed

Stained Tall Grasses in Creekbed

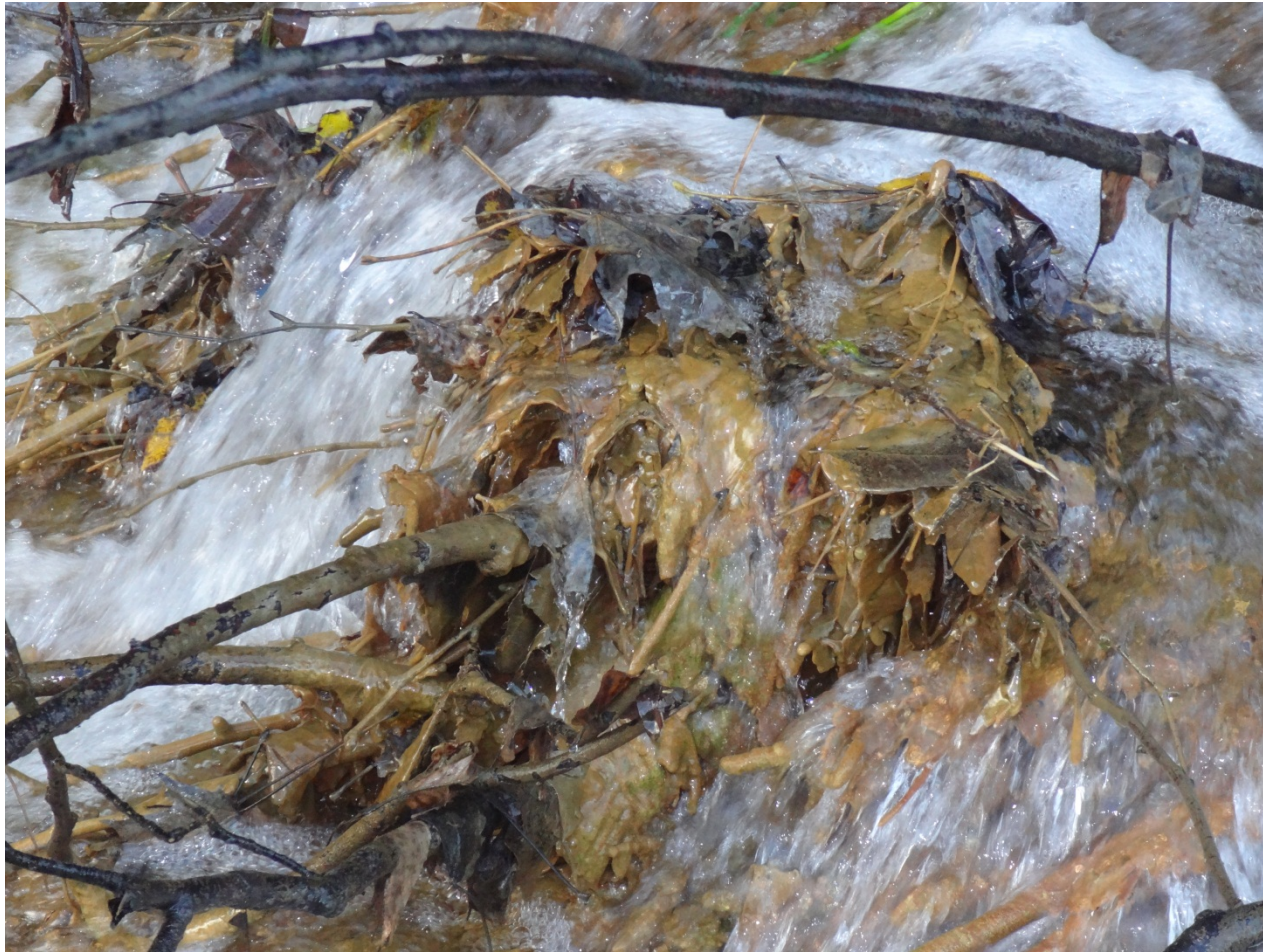
Refuse Outlet Spillway – Pre KR-DP0168 Feed

Close-up of Stained Tall Grasses in Creekbed

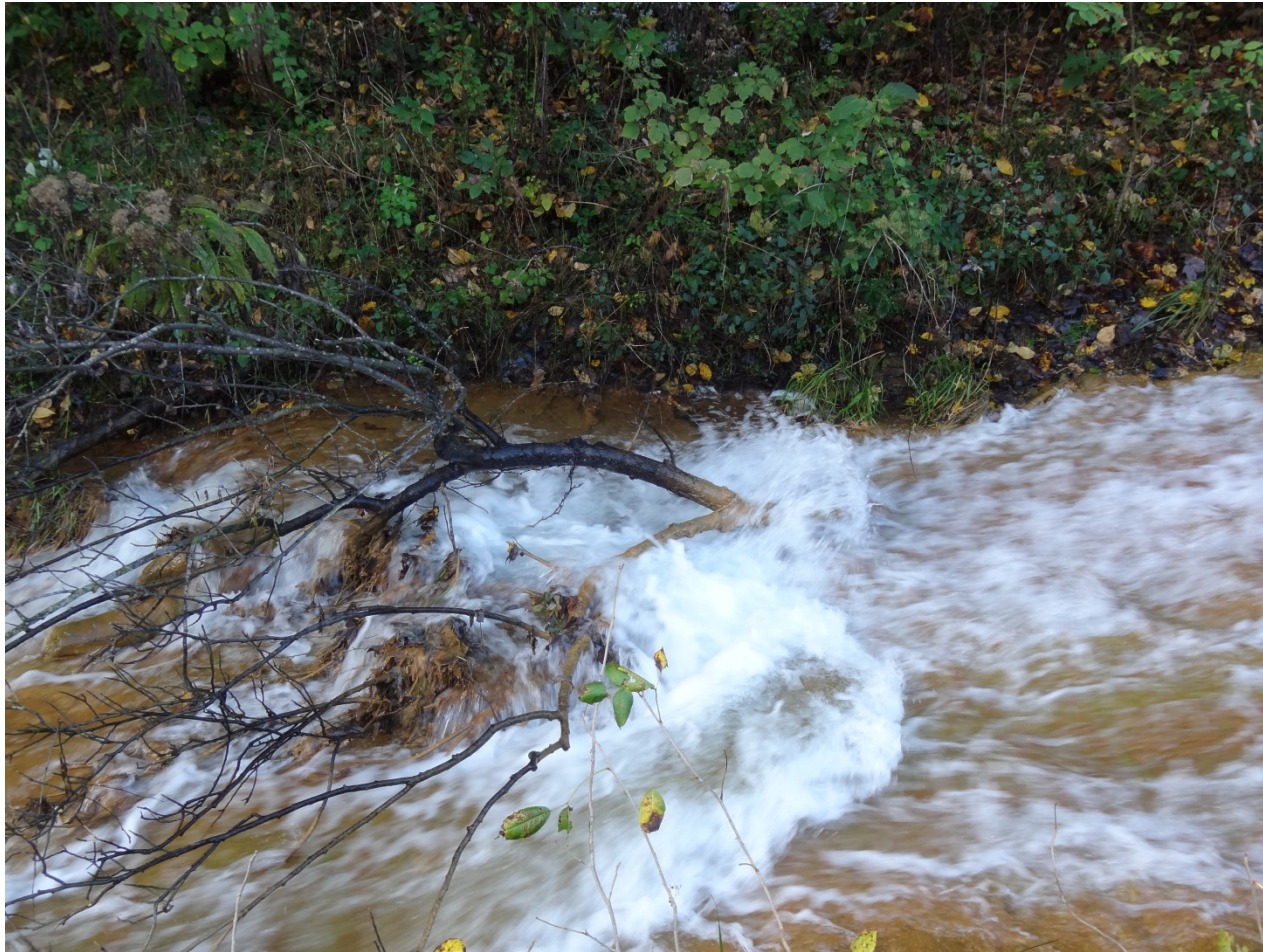
Refuse Outlet Spillway – Pre KR-DP0168 Feed

Staining Evident on Submerged Tree Limb

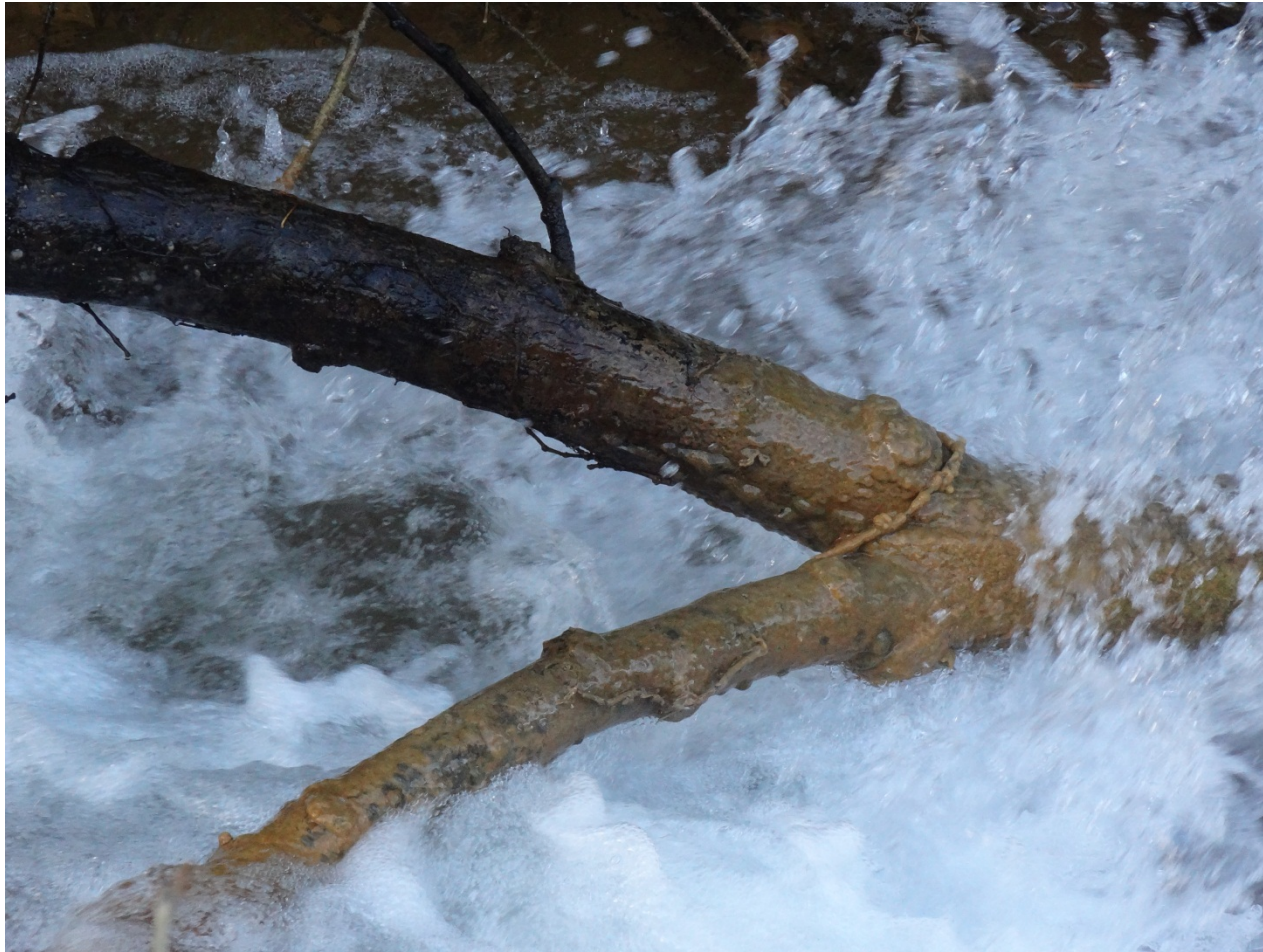
Refuse Outlet Spillway – Pre KR-DP0168 Feed

Close-up of Submerged Tree Limb

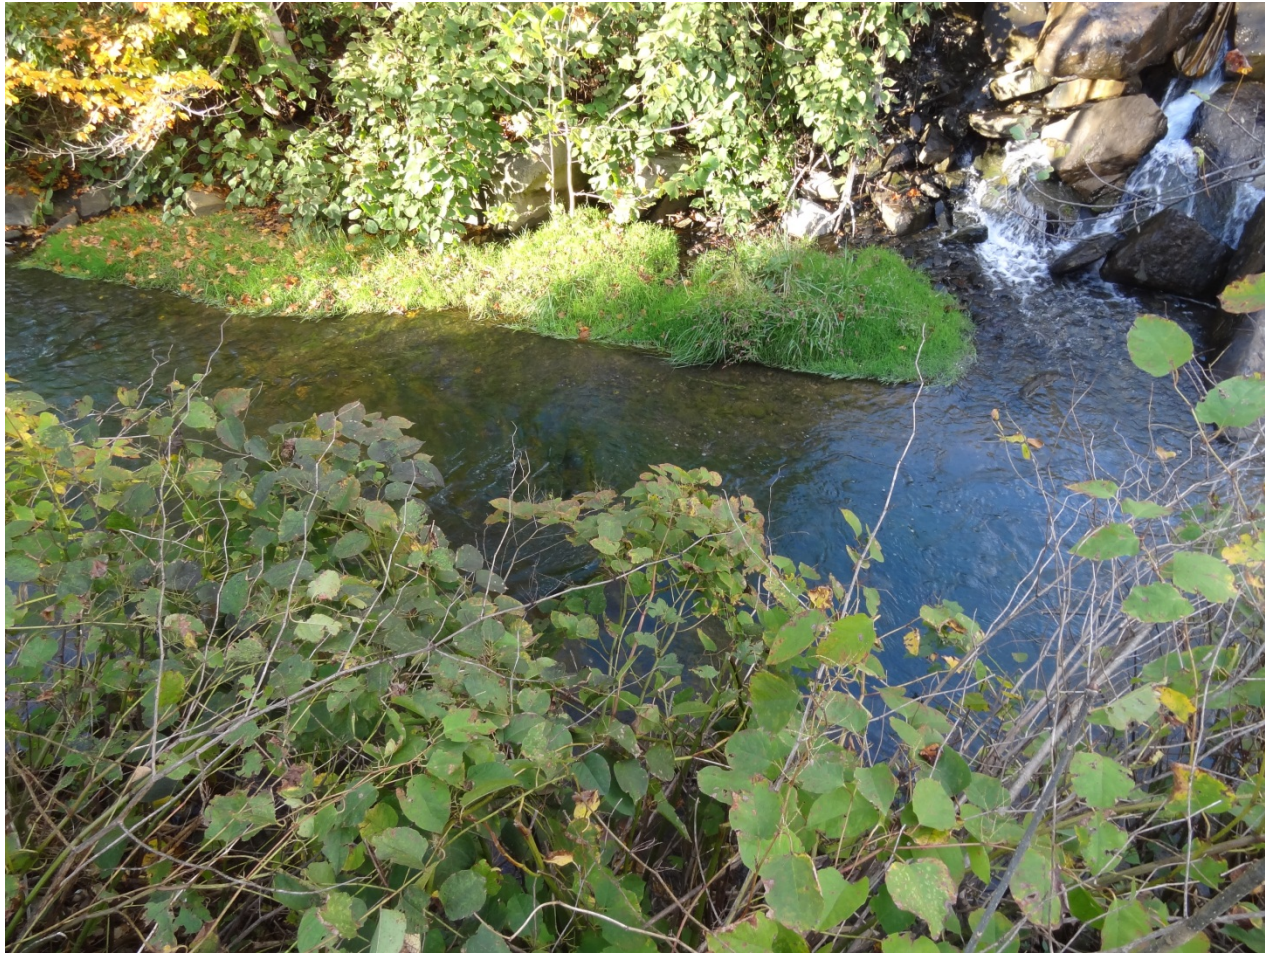
Main Outlet – Good Clarity

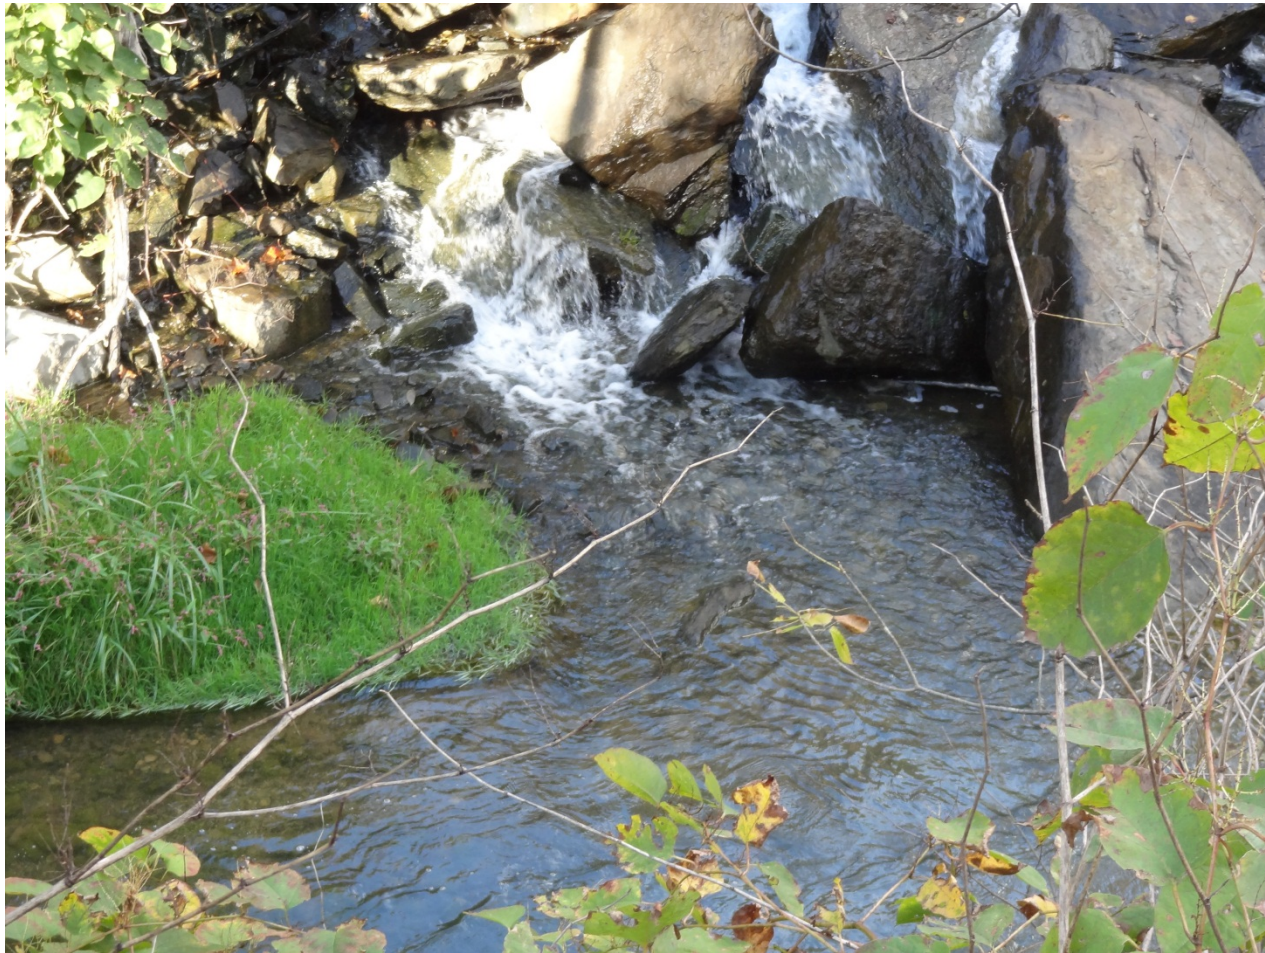
Main Outlet

Close-up of Discharge into Creekbed

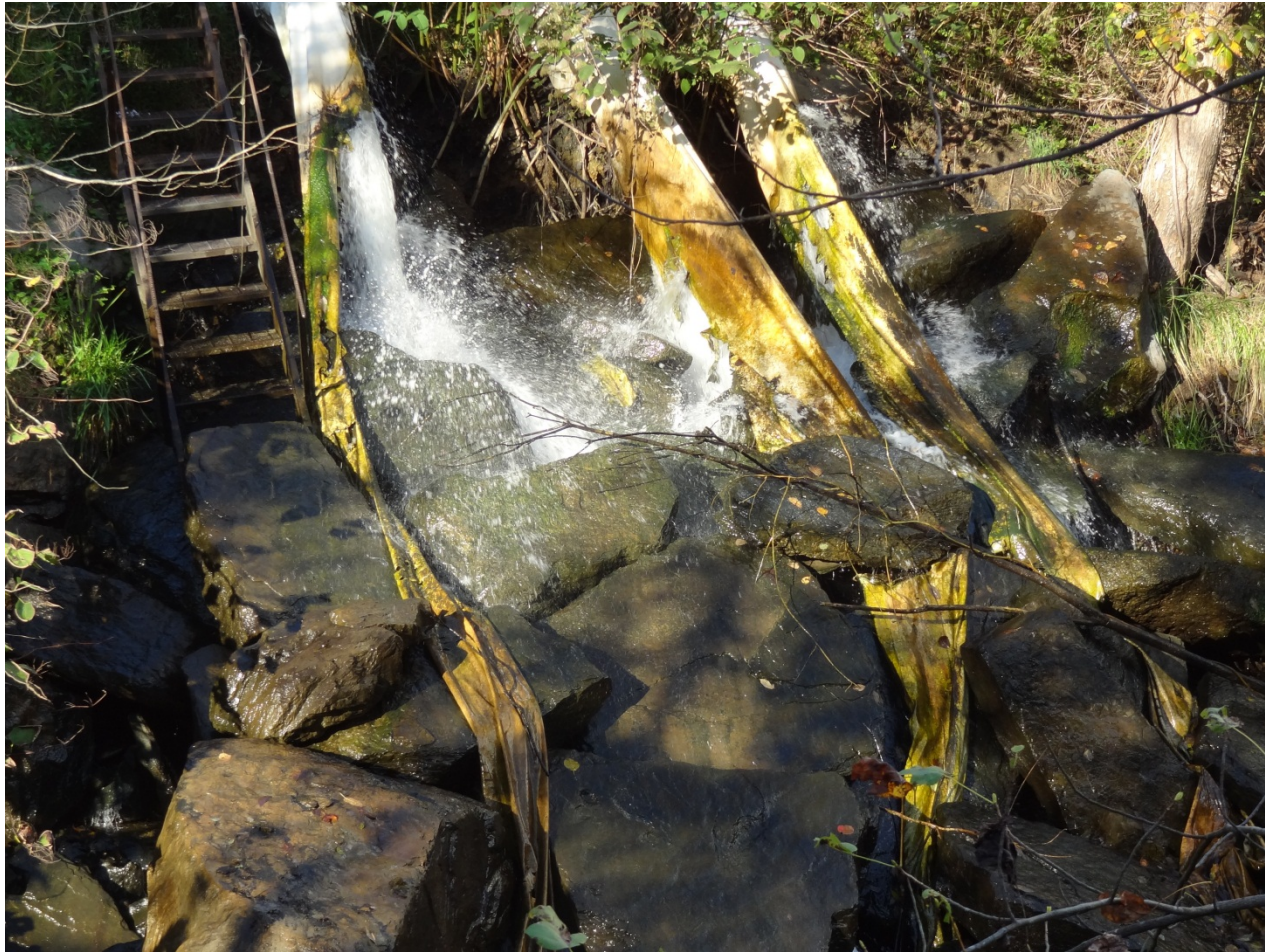
Main Outlet

Outlet Rock Slabs – No Staining
